Coconut Grove Playhouse Historic Report

Jorge L Hernandez Preservation Architect

For Arquitectonica International

12.08.16

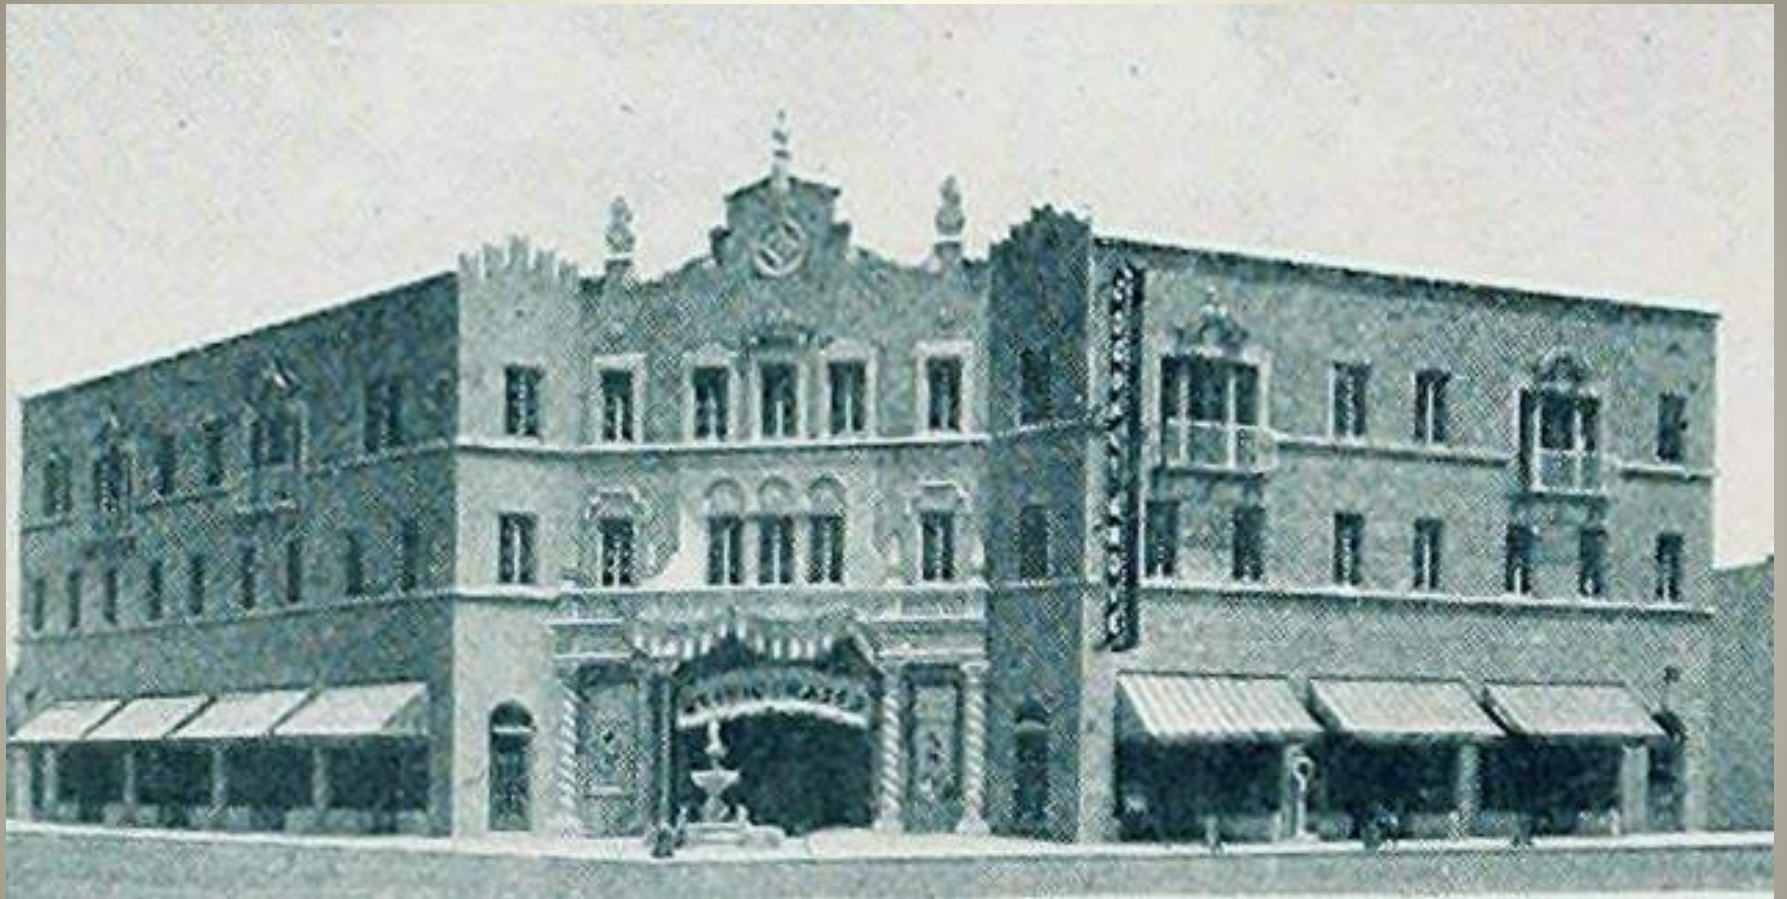
Coconut Grove Theater, 1927
Front Elevation

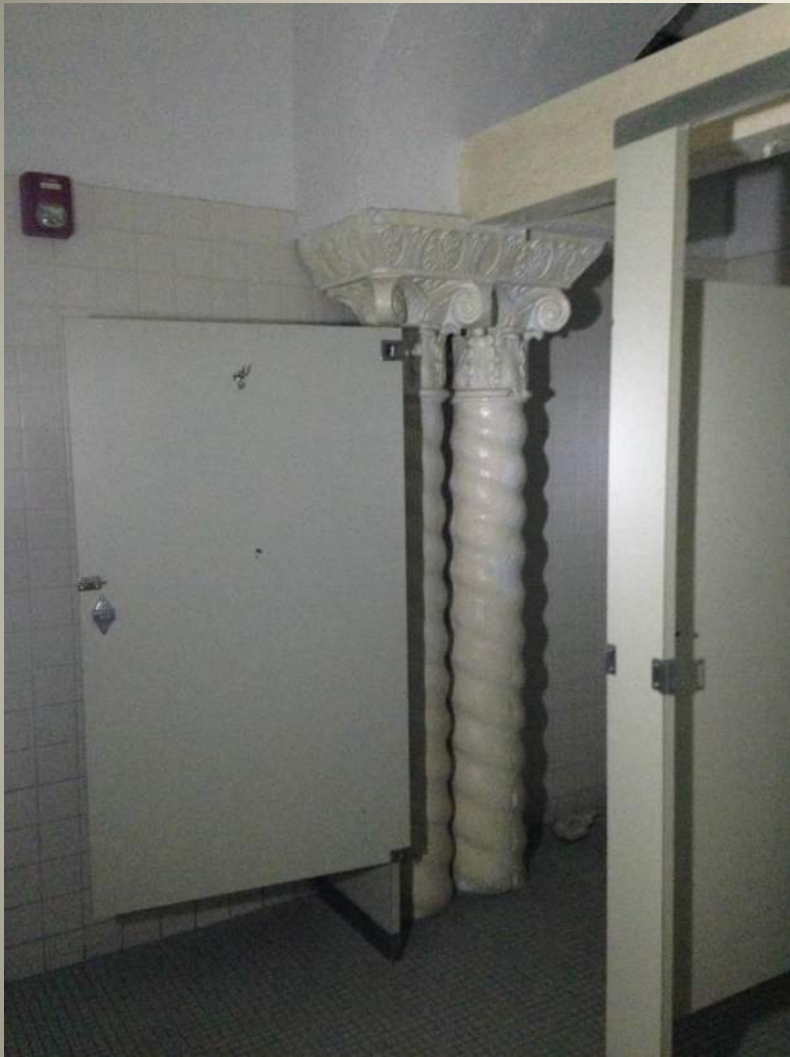
Solomonic Columns now located in the restroom. Due to the change in floor slope, the bases are now below the floor slab.

Solomonic Columns now located in the restroom. Due to the change in floor slope, the bases are now below the floor slab.

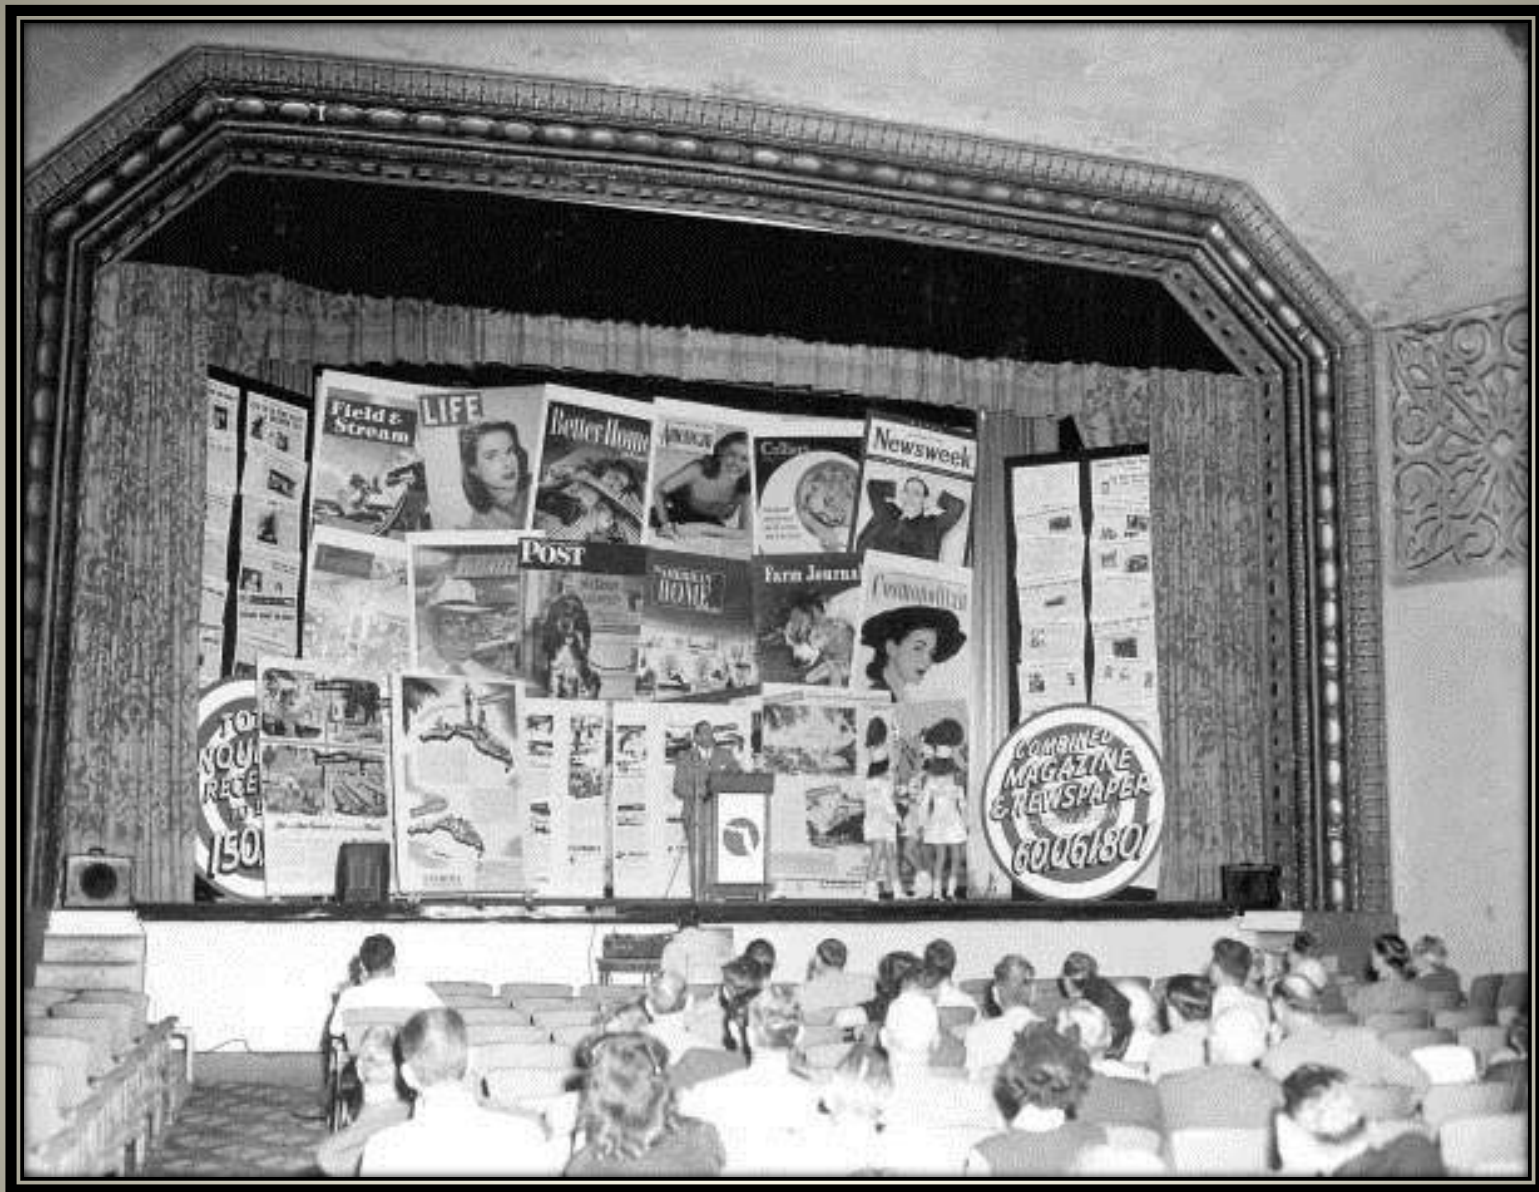
Coconut Grove Theater view of the proscenium arch
(photo 1946)

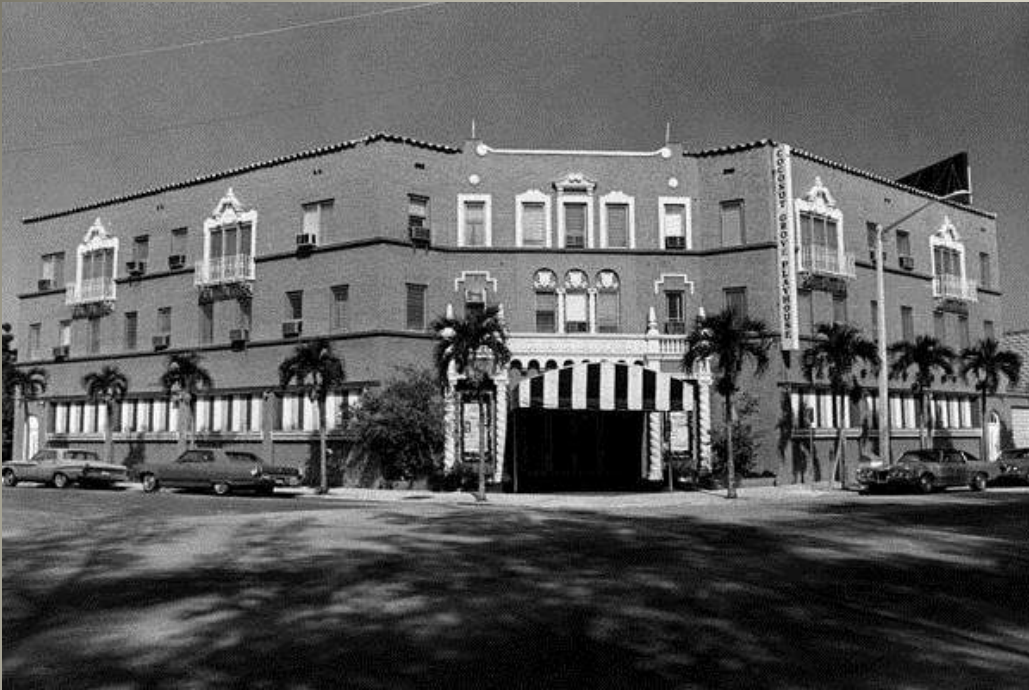
Coconut Grove Playhouse front elevation showing the elevated planters (Photo 1984)

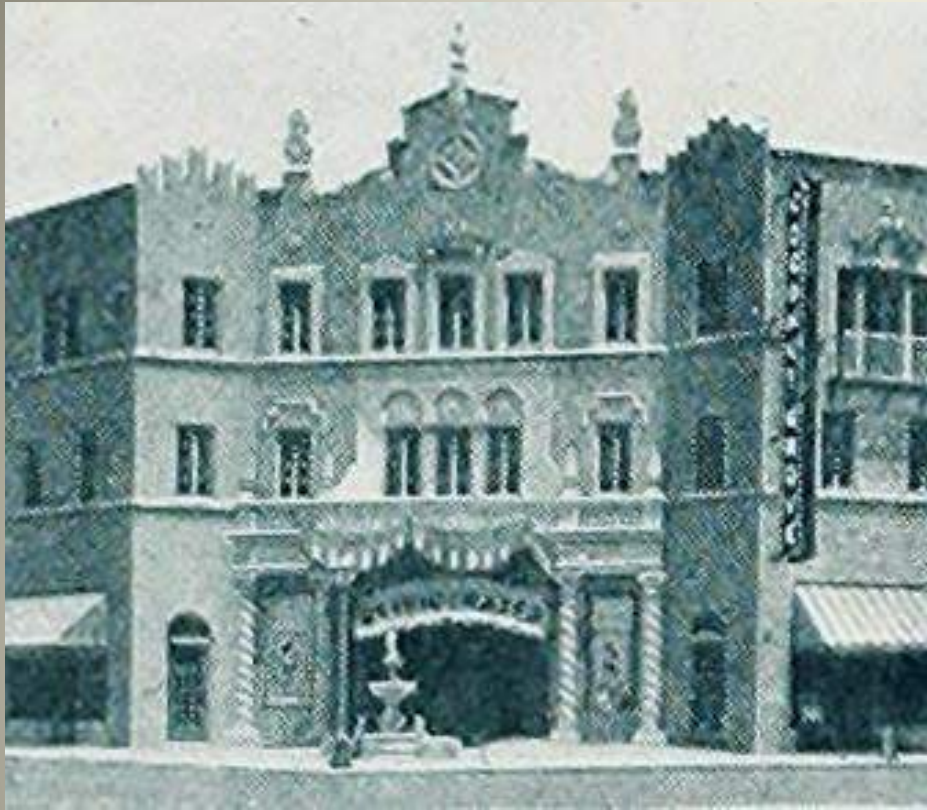
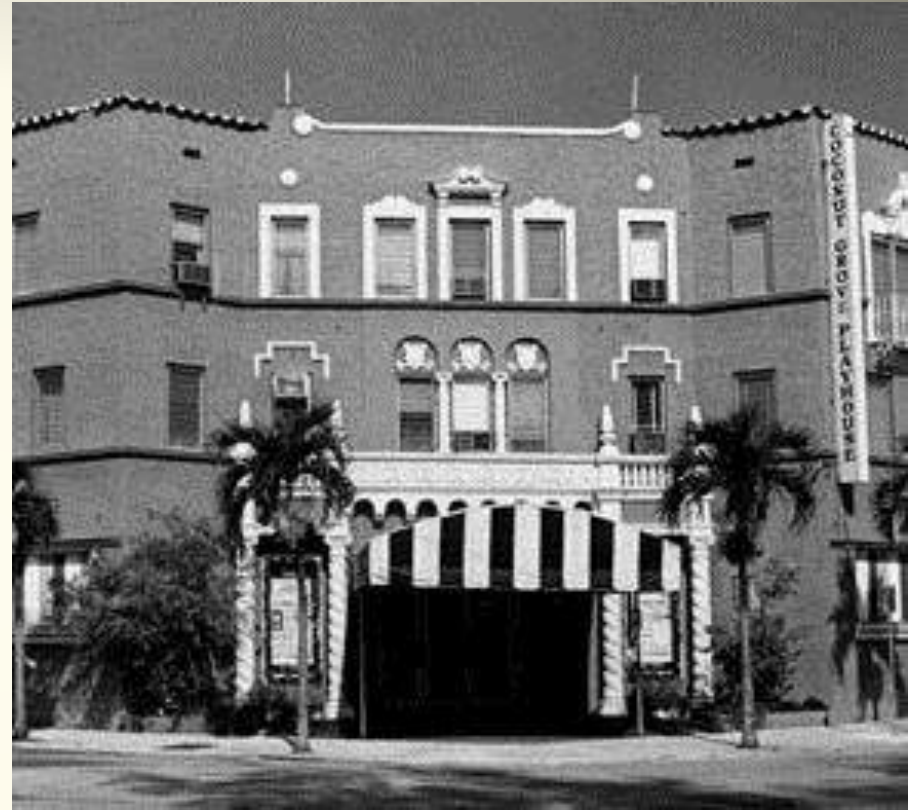
Comparison of the 1926 and 1971 Coconut Grove Playhouse front elevations showing the removal of the crenellation along the roof line.

Comparison of the 1926 and 1971 Coconut Grove Playhouse front elevations showing the removal of the crenellation along the roof line.
